**FINAL REPORT
MARCH 2004**

REPORT NO. 04-08

**INTERMODAL STORAGE AND TRANSPORT FRAME (ISTF),
MIL-STD-1660, "DESIGN CRITERIA FOR AMMUNITION UNIT LOADS"
TESTING**

**INTERMODAL STORAGE AND TRANSPORT FRAME (ISTF),
MIL-STD-1660, "DESIGN CRITERIA FOR AMMUNITION UNIT LOADS"
TESTS**

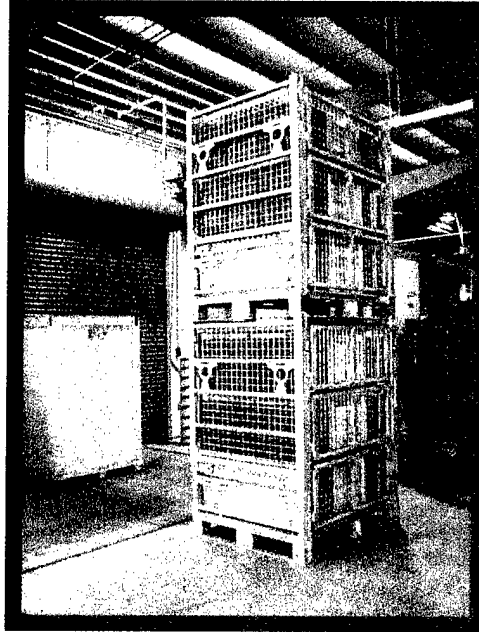
1. COMPRESSION TEST. The Test Unit #1 was compressed with a load force of 3,530 pounds for 60 minutes on 3 February 2004. Test Unit #2 was used as the load force for the test. No damage was noted as a result of this test. See Photo 5 of the test specimen in the compression unit.

Photo 5. ISTF Unit #1 During Compression Testing.

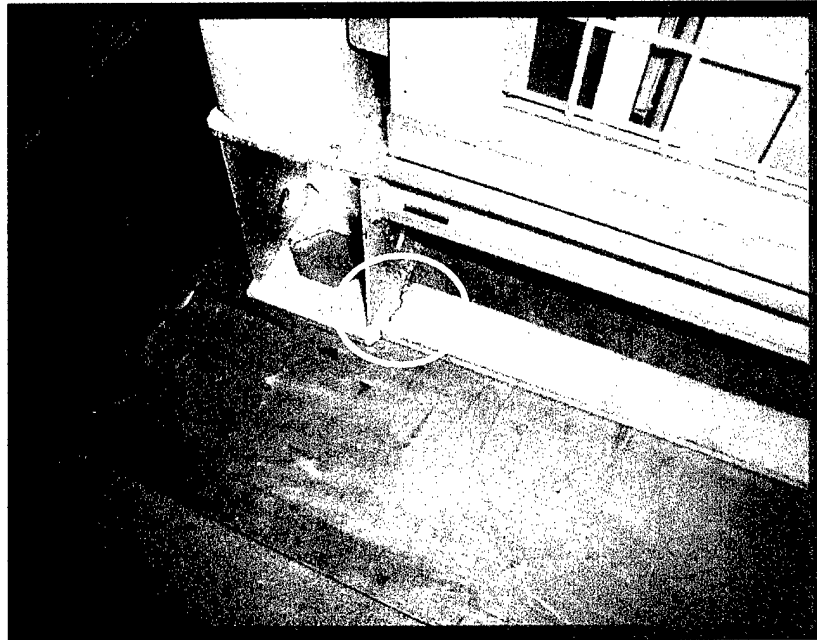
2. **REPETITIVE SHOCK TEST.** The specimen was vibrated 90 minutes at 227 RPM in the lateral orientation and 90 minutes at 212 RPM in the longitudinal orientation. A cracked weld occurred along the base support. Cracks also occurred in some of the welds at the base of the corner post. Photo 6 shows the specimen on the vibration platform. Photo 7 shows the cracked base weld and Photo 8 shows an example of the cracked weld along the ISTF corner post.

Photo 7. ISTF Unit #1 Cracked Weld on the Base Structure.

Each unit sustained weld cracks that occurred at the base of the corner posts. These weld cracks are an area of concern and should be evaluated by the manufacturer and design improvements identified. Each unit had cracked welds along the base. Inspection also revealed that each unit had bent wire mesh. The bent wire mesh was located in the frame end walls and was not significant. The damage was caused by impact of the wooden and metal containers against the mesh. The ISTF units remained intact and were capable of safely handling ammunition after completion of testing. The ISTF units successfully completed the test requirements of MIL-STD-1660 and are approved for the transport of ammunition. Also, instructions should be provided with each ISTF to ensure proper assembly/disassembly.

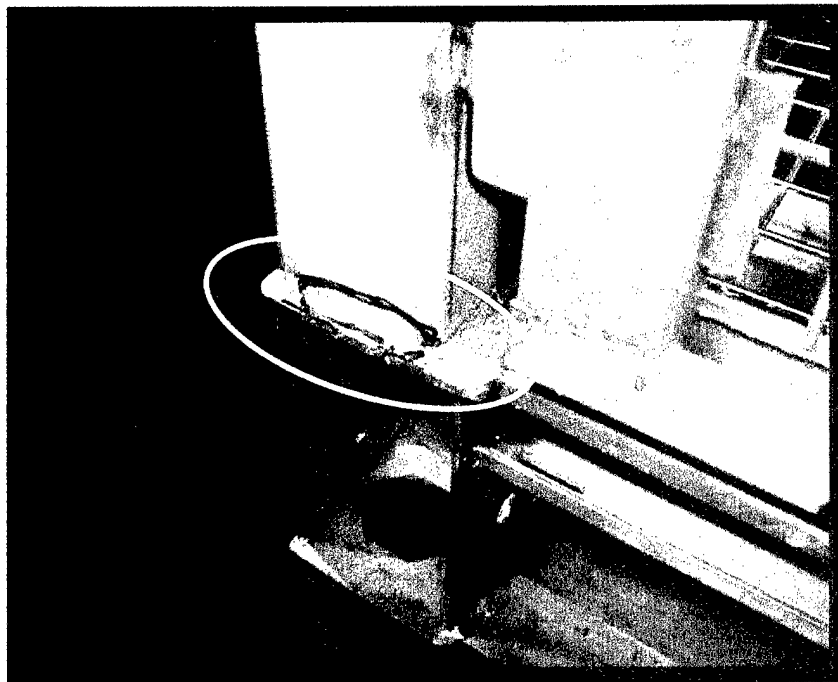
Photo 8. ISTF Unit #1 Cracked Weld Along the Corner Post.

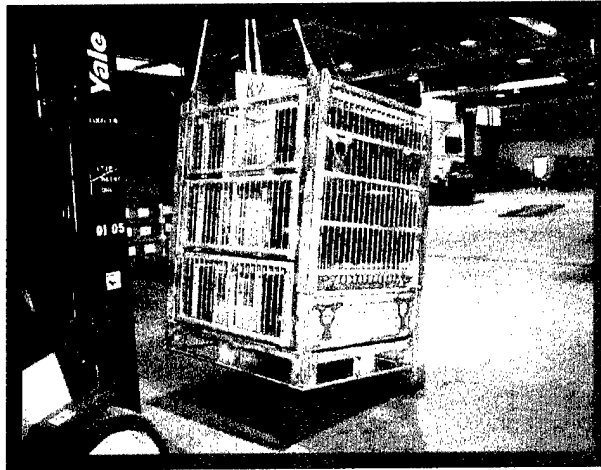
3. EDGEWISE ROTATIONAL DROP TEST. The specimen was edgewise rotationally dropped from a height of 12 inches on both longitudinal sides and both lateral sides. Photo 9 shows the specimen during the drop test.

Photo 9. Edgewise Rotational Drop Test on the ISTF Unit #1.

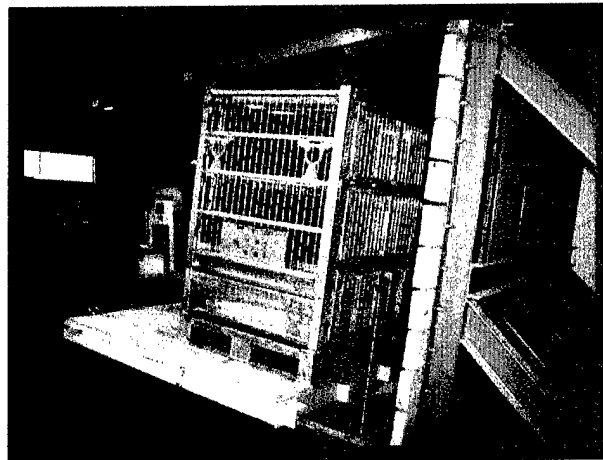
4. INCLINE-IMPACT TEST. The specimen was impact tested on both longitudinal sides and both lateral sides. No significant damage was noted as a result of this test to the ISTF Unit #1. See Photo 10 for the specimen during the lateral incline-impact test.

Photo 10. Incline-Impact Testing of the ISTF Unit #1.

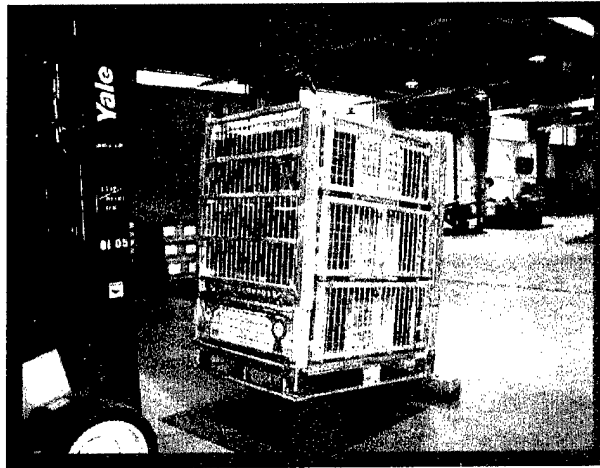
3. EDGEWISE ROTATIONAL DROP TEST. The specimen was edgewise rotationally dropped from a height of 12 inches on both longitudinal sides and both lateral sides. Cracks occurred in some of the welds at the base of the corner post. No significant damage was noted as a result of this test. Photo 16 shows the specimen during the drop test and Photo 17 shows the corner post weld crack.

Photo 16. Edgewise Rotational Drop Test on the ISTF Unit #2.
